## Yellow Flag NB2228W019

**BIN: 1065318**

Feature Carried: 278I278IX2M23027

Feature Crossed: 6TH AVENUE

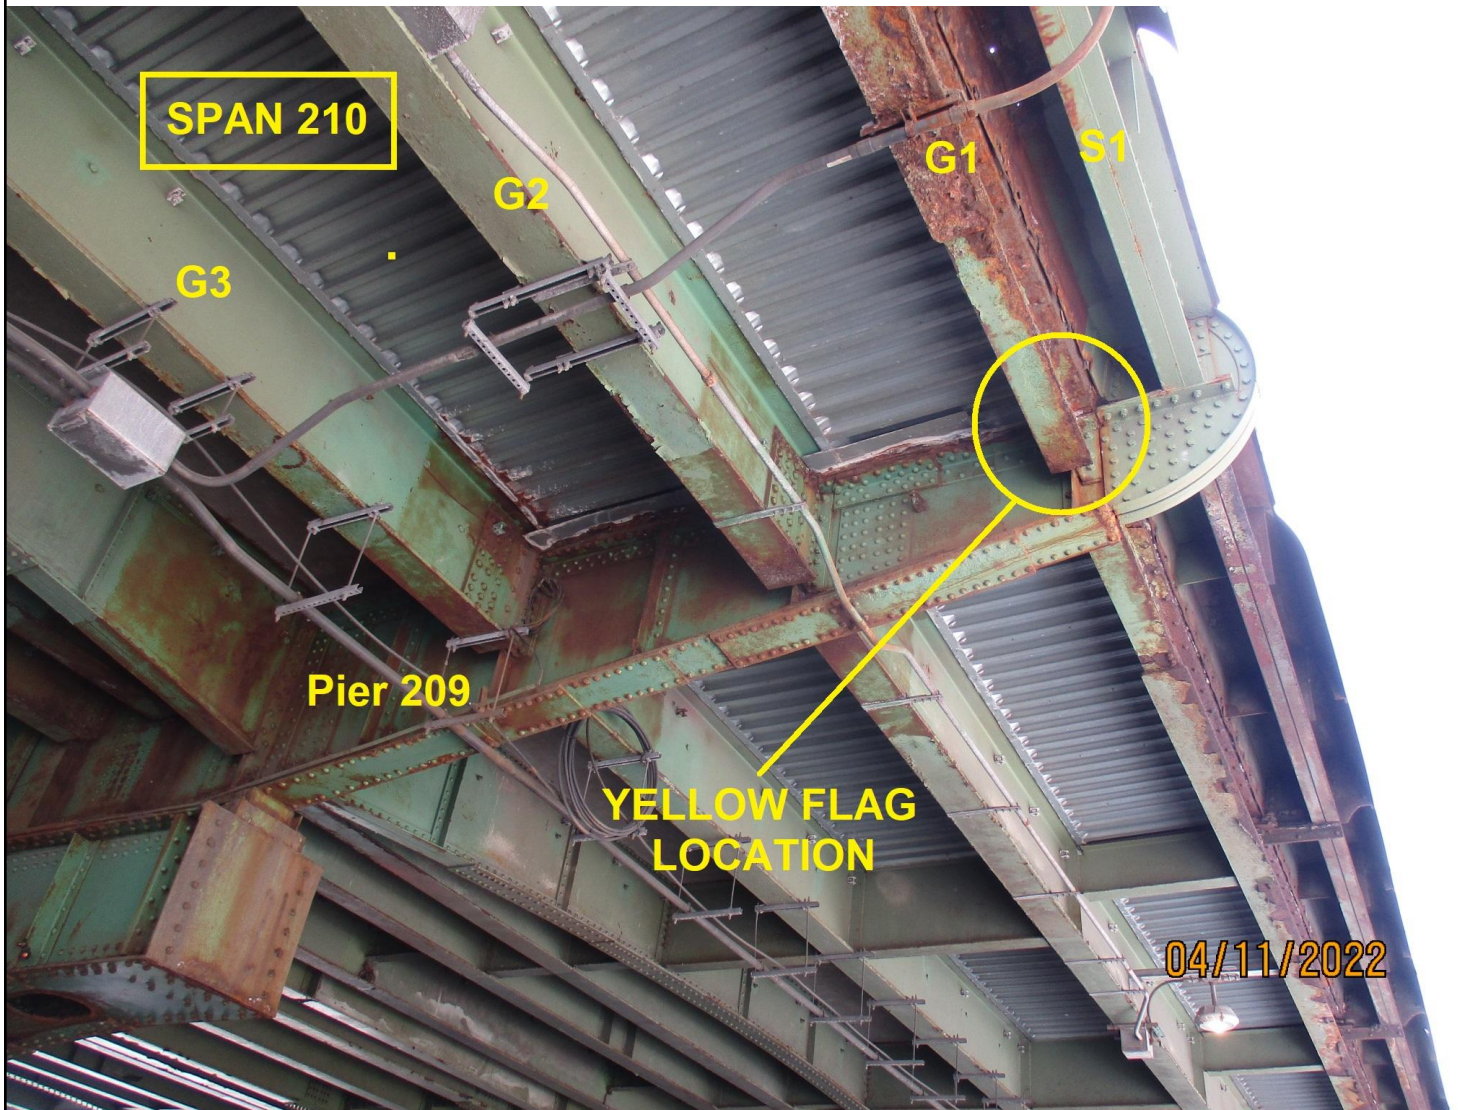
Photo Number: 1

**Attachment Description:** Span 210 Girder G1 at Pier 209. General view of the flagged location. Looking Begin.

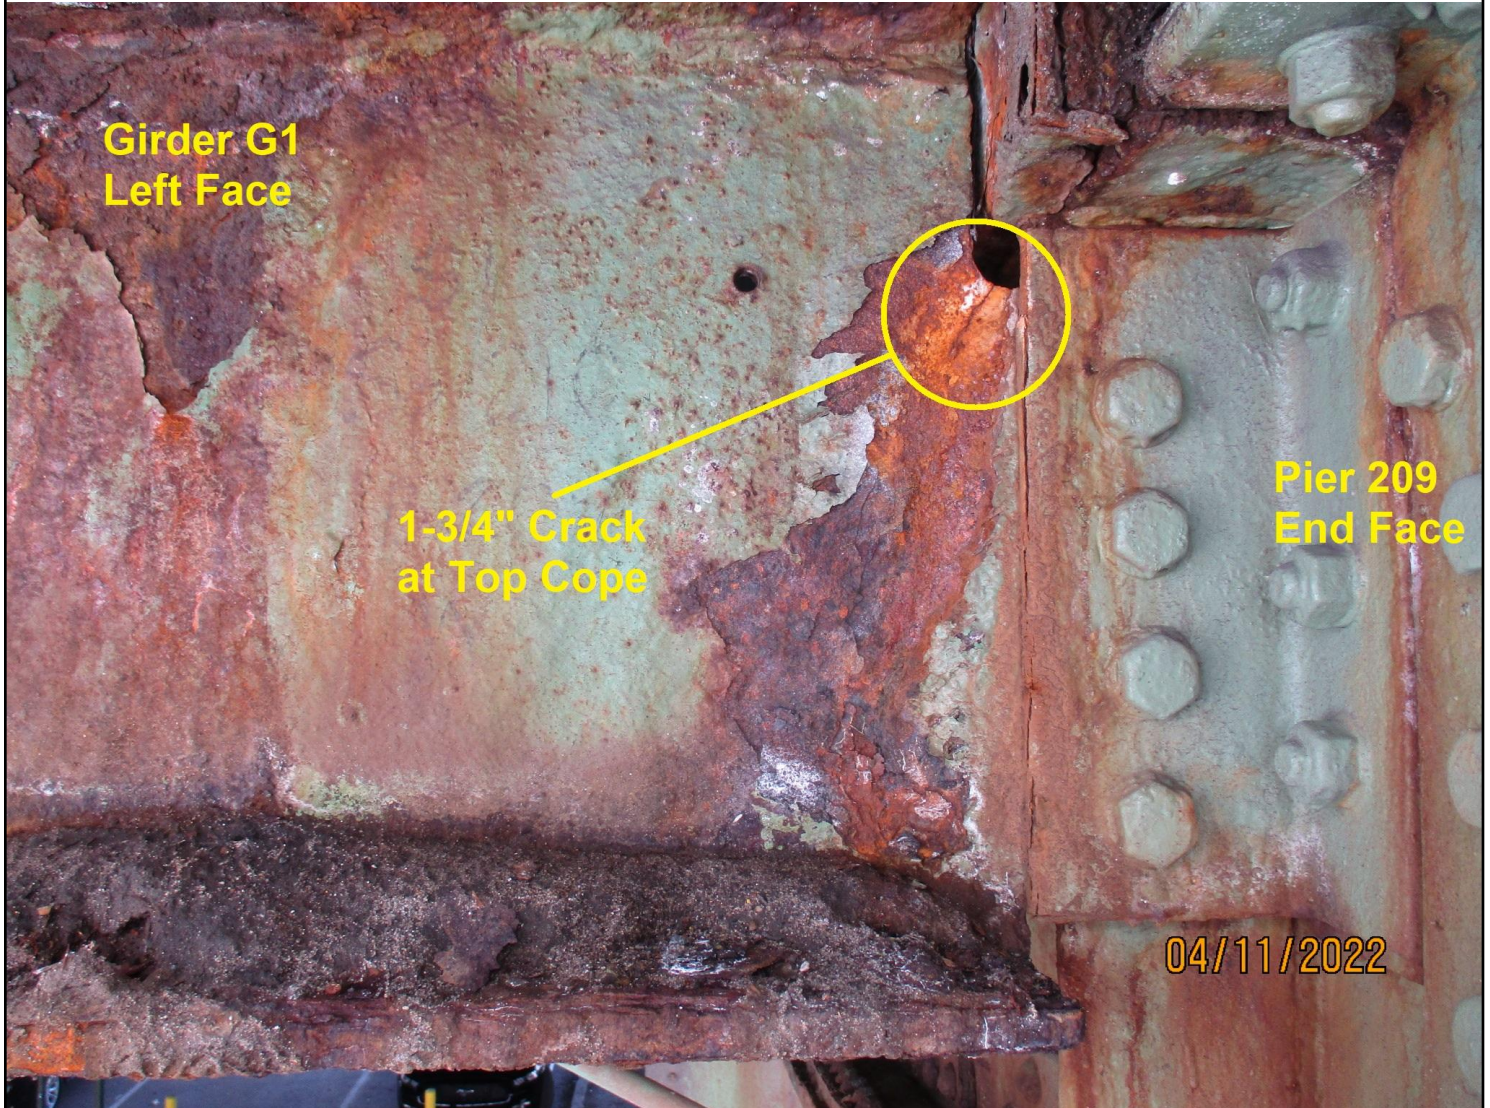
Photo Number: 2

**Attachment Description:** Span 210 Girder G1 at Pier 209. General view of the left side of web showing the 1-3/4"L crack at the top cope. Looking Right. Note: Heavy accumulation of dirt and debris on top of bottom flange.

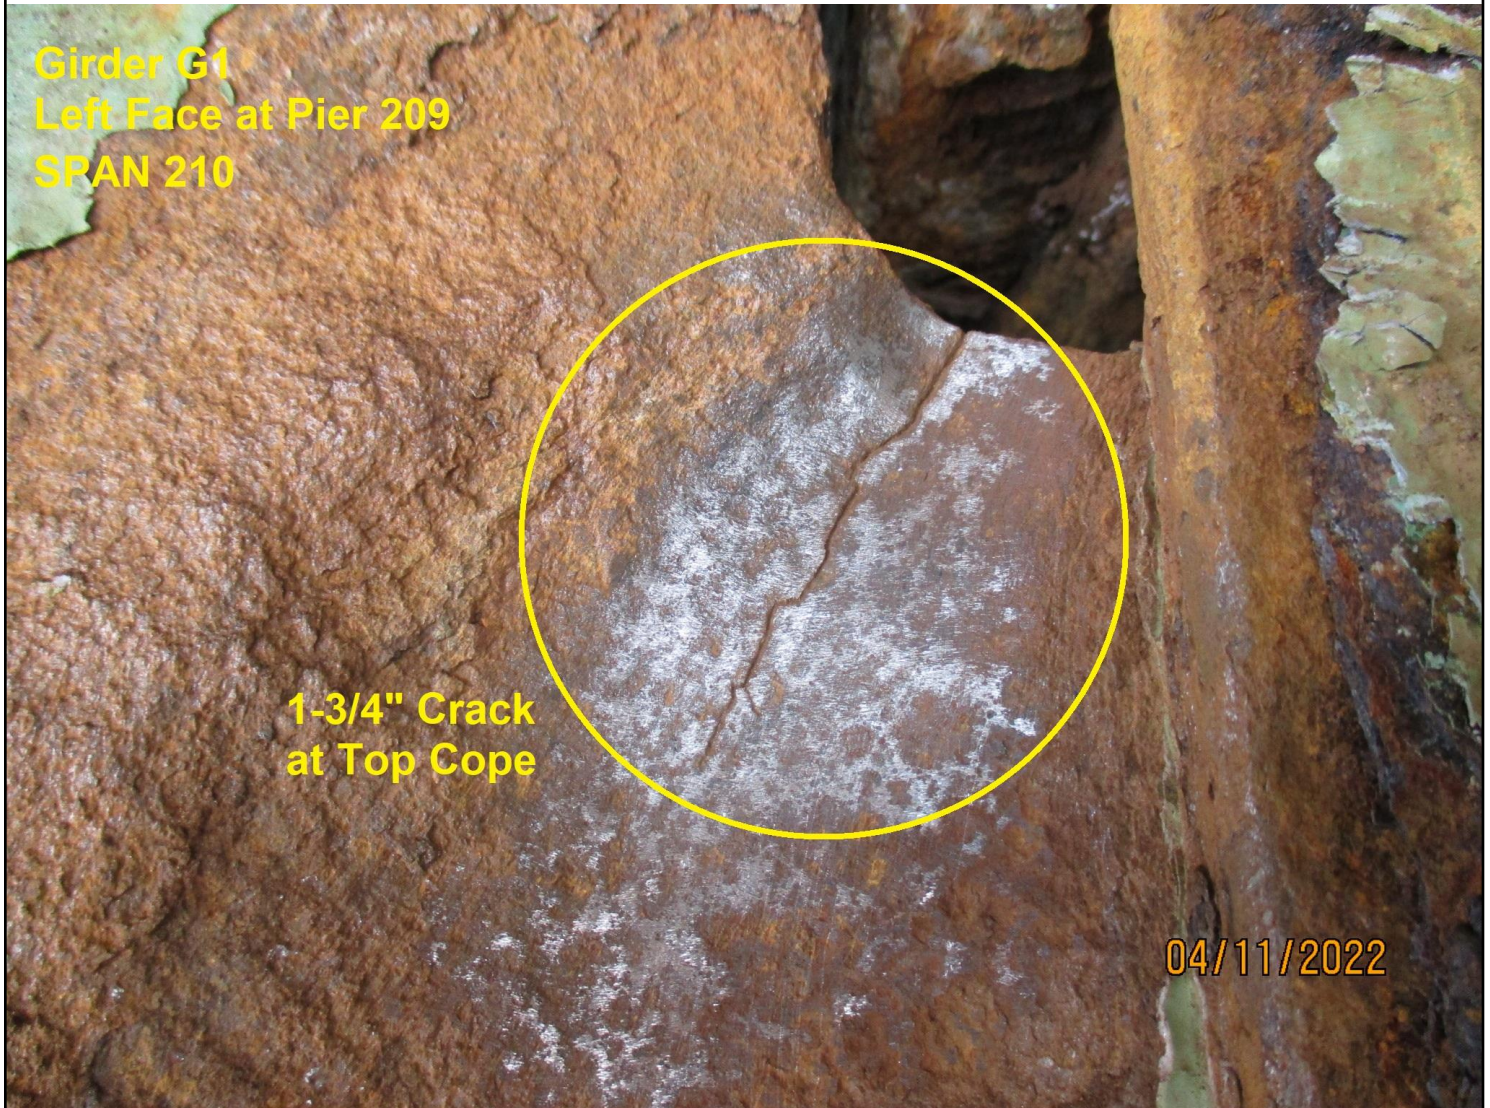
Photo Number: 3

Description: The end of Girder G1 in Span 210 at Pier 209 exhibits a diagonal thru crack, 1-3/4" long at the top cope. The girder frames into the web of the pier.

**Attachment Description:** Span 210 Girder G1 at Pier 209. Close-up view of the flagged location showing a diagonal thru crack 1-3/4" long at the top cope. Looking Right.

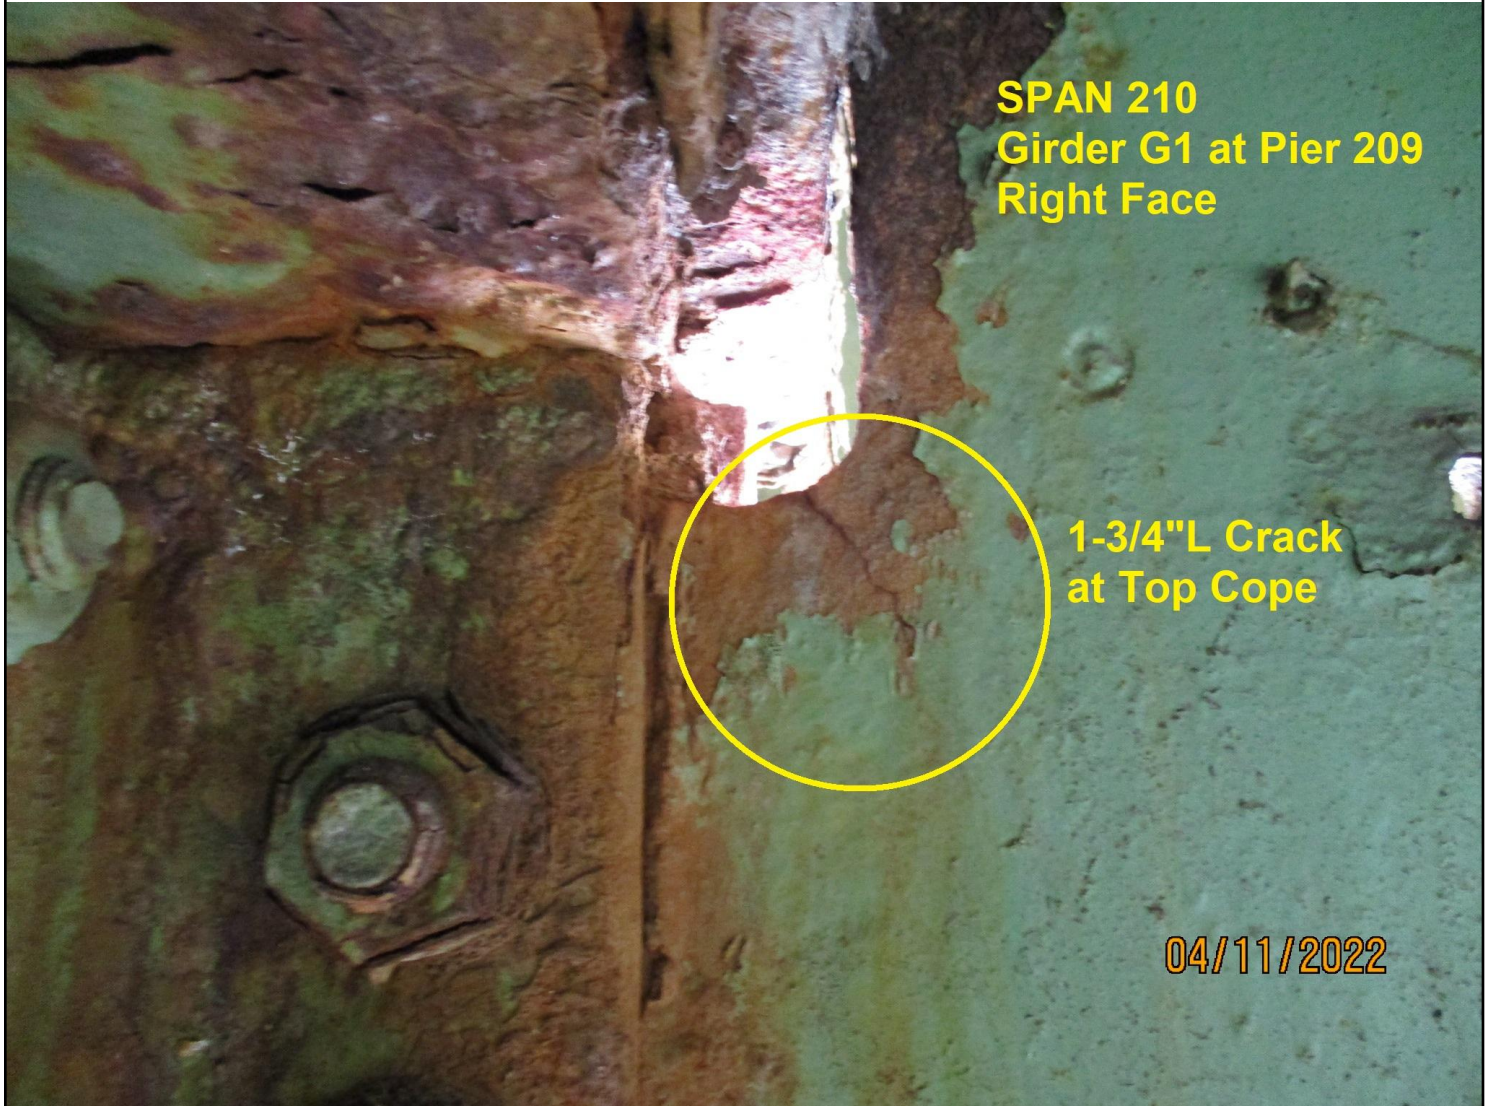
Photo Number: 5

**Attachment Description:** Span 210 Girder G1 at Pier 209. Close-up view of the flagged location showing a diagonal thru crack 1-3/4" long at the top cope. Looking Left.

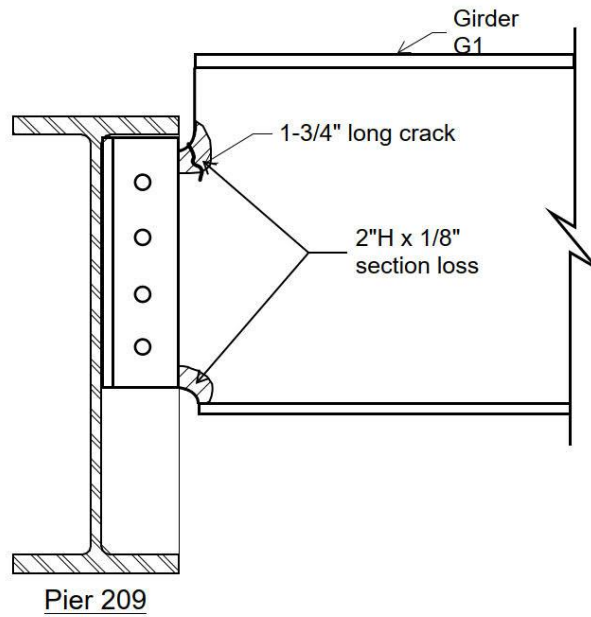
**SPAN 210, GIRDER G1 BEAM END AT PIER 209****(LOOKING LEFT)****N.T.S**

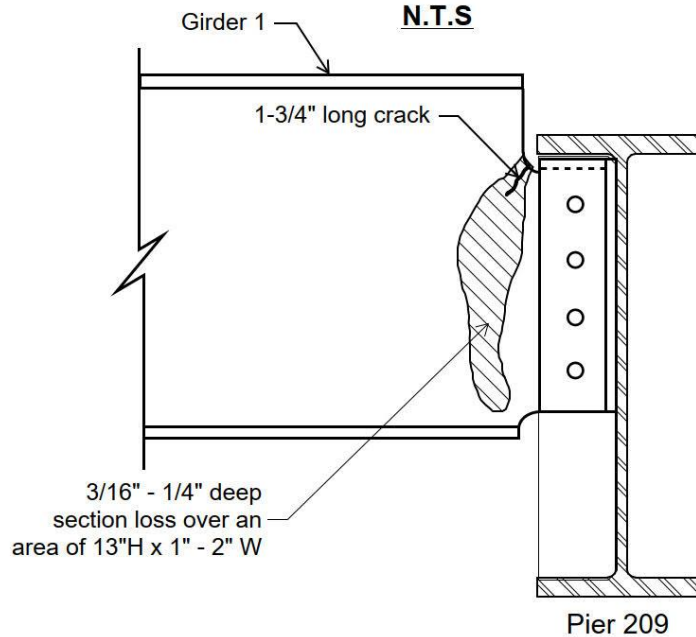
**SPAN 210, GIRDER G1 BEAM END AT PIER 209****(LOOKING RIGHT)****N.T.S*****Attachment Description: SN 210 G1 at Pier 209 Sketch***
